**United States Environmental Protection Agency
Criminal Investigation Division
Investigative Activity Report**

Fortymile: [REDACTED] Placer Mine Investigation (APMA
[REDACTED])

Mine Discharge Investigation at the APMA [REDACTED] Mine 08-22-13

Mine Discharge Investigation at the APMA [REDACTED] [REDACTED] Mine (08/22/13)

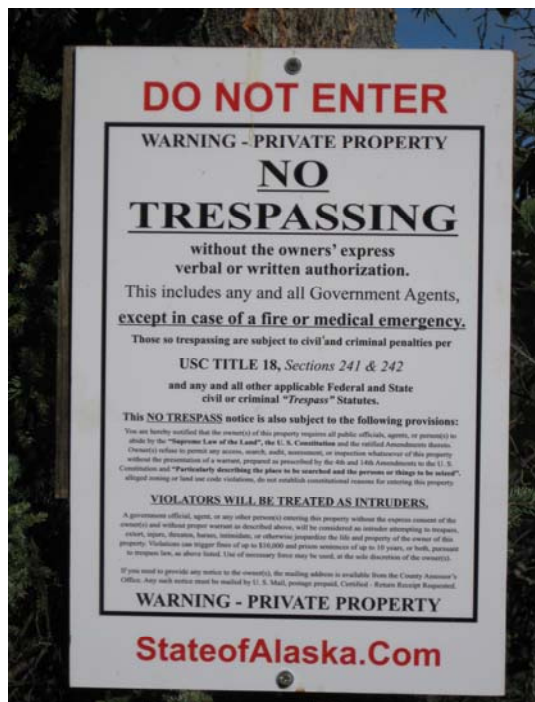
On 08/21/13 at approximate 10:22AM, an investigative ground team comprised of EPA Special Agent [REDACTED] EPA Special Agent [REDACTED] BLM Special Agent [REDACTED] and BLM Special Agent [REDACTED] attempted to enter the Canyon Creek drainage area from the south by means of ATV, along a public-access gravel road.¹ Access to the gravel road was made from the Top of the World Highway, near the Boundary, Alaska landing strip. Approximately 200 yards along the gravel road from the Top of the World Highway, prior to entering the [REDACTED] mine site, the ground team encountered a “No Trespassing” sign posted to a tree along the public-access gravel road leading to multiple regulated mine sites.² See Attachment 1, **GIS Mine Claim Map with Investigative Notations**. EPA Special Agent [REDACTED] took a photograph of the posted sign, **Photograph 5**, which included the following language:

Photo 5: Sign posted along public access road leading into Canyon Creek.

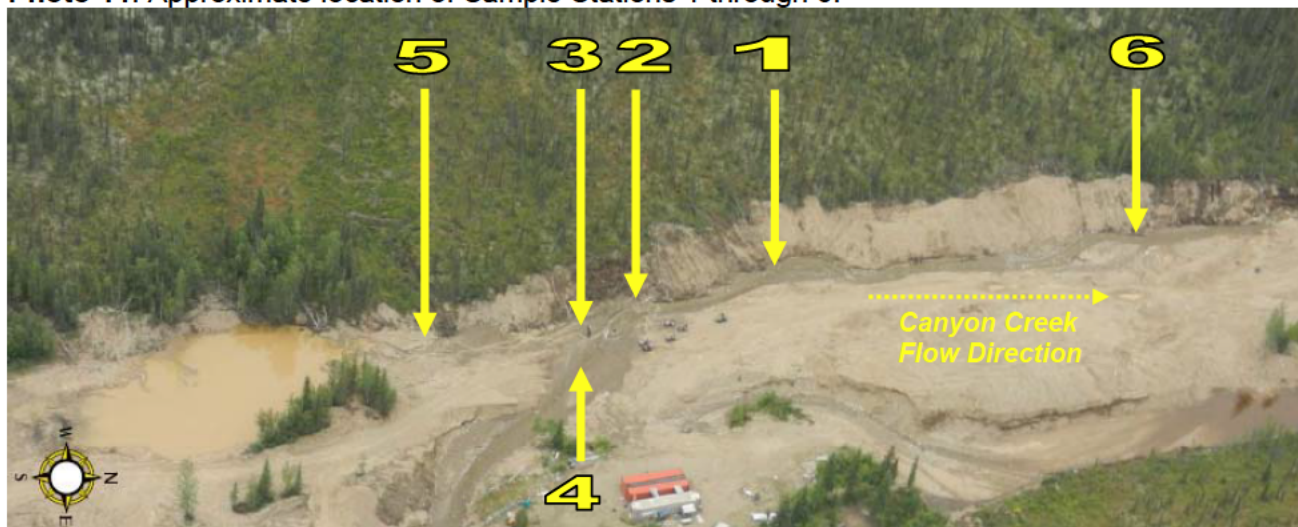
For reference purposes, **Photograph 11**, taken by Special Agent [REDACTED] on 08/22/13 at approximately 4:35PM and is annotated to depict the approximate sample station locations for the six samples collected at the northernmost (downstream) area of [REDACTED] mine. Three additional samples were collected upstream of [REDACTED] washplants and are reported in Section 11 of this report. Reference DSCN1692.

Photo 11: Approximate location of Sample Stations 1 through 6.

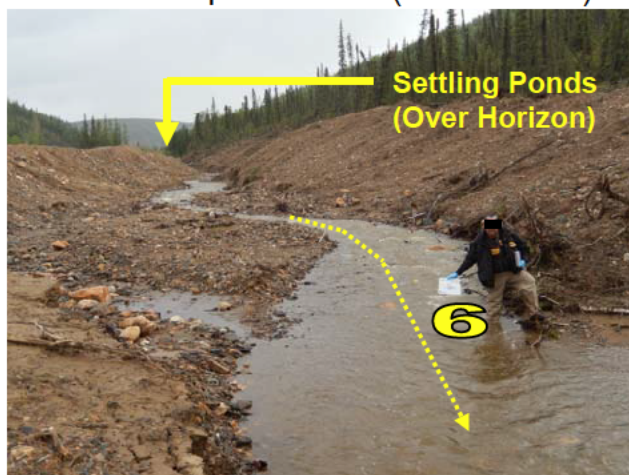
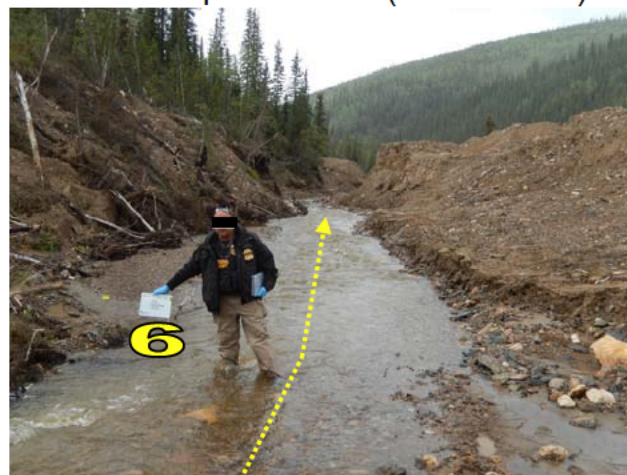
Photo 19: Sample Station 6 (Downstream)

Photograph 19 and **Photograph 20** were taken by Special Agent [REDACTED] on 08/22/13 at approximately 4:53PM and depict the source location for the collection of a downstream creek sample from **Sample Station 6**. The person appearing in the photograph is Special Agent [REDACTED], identifying the referenced sample station's location.

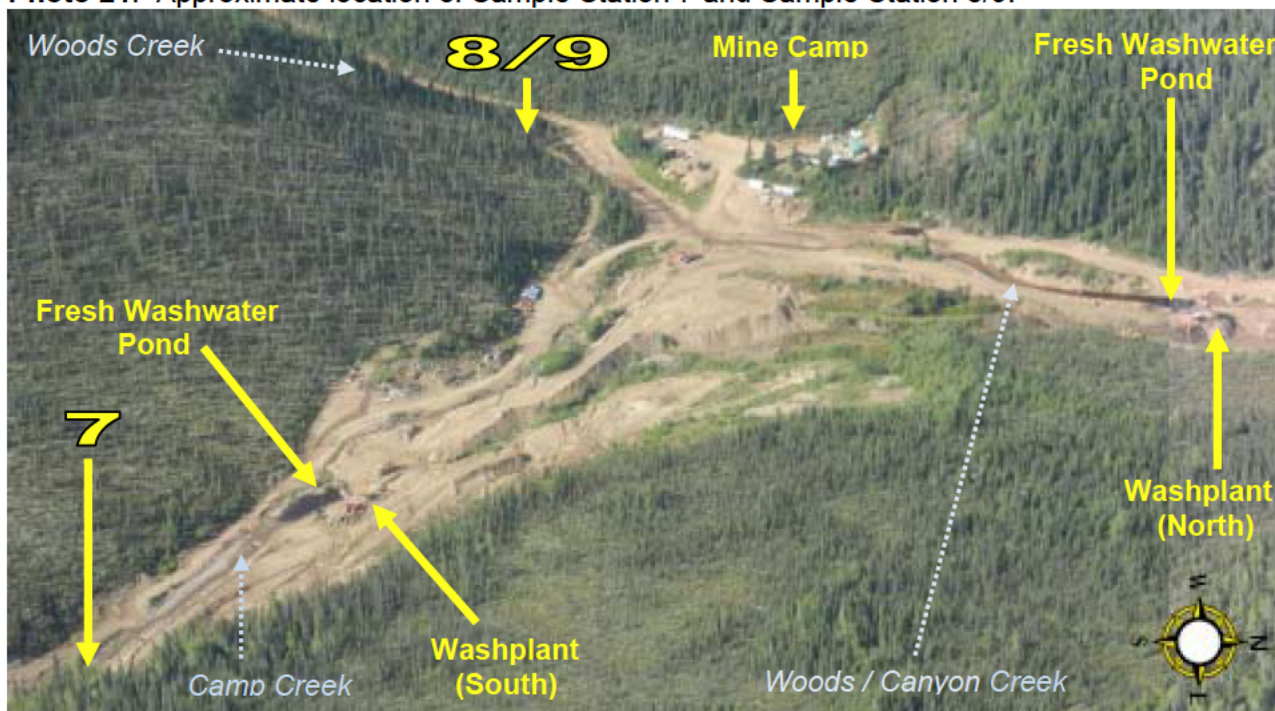
Photograph 11 on page 11 depicts the relative location of background **Sample Station 4** to the point of discharge. **Photograph 21** below depicts the relative location of background **Sample Station 7** and background **Sample Station 8/9** to the mine's two washplants. This photograph is a composite of photographs DSCN1626 and DSCN1627 taken by Special Agent [REDACTED] on 08/22/13 at approximately 11:52AM.

Photo 21: Approximate location of Sample Station 7 and Sample Station 8/9.

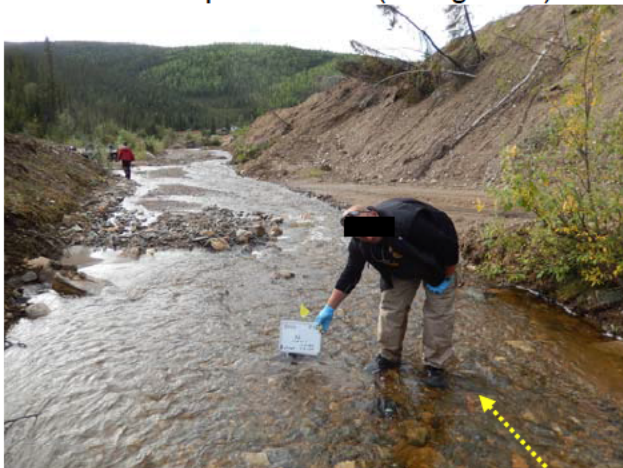
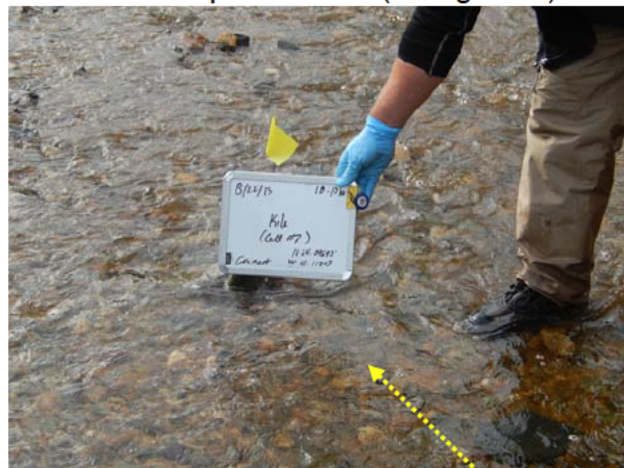
Photo 23: Sample Station 7 (Background)

Photograph 23 and **Photograph 24** were taken by Special Agent [REDACTED] on 08/22/13 at approximately 6:12PM and depicts the source location for the collection of a background creek sample from **Sample Station 7**.

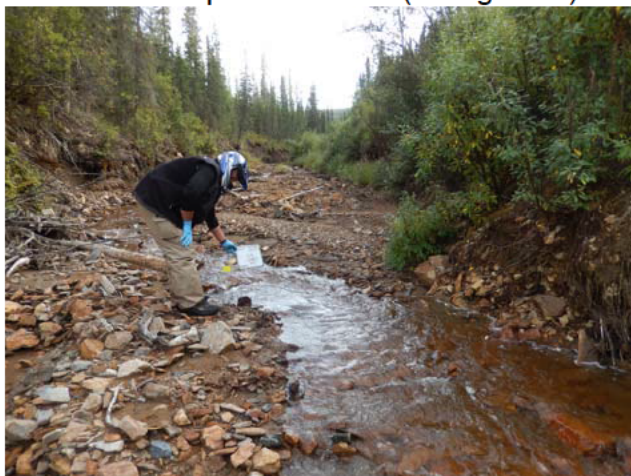
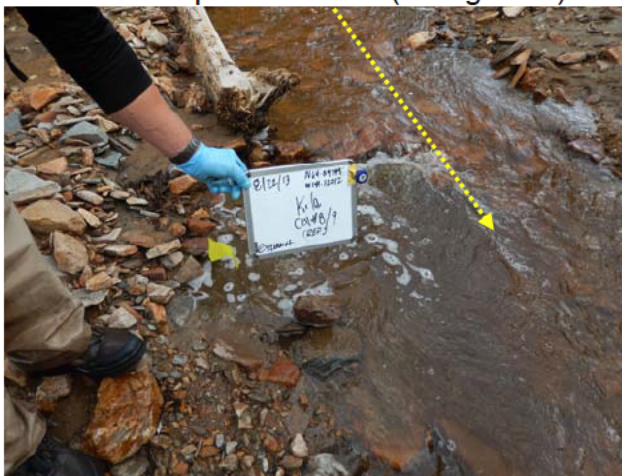
Photo 25: Sample Station 8/9 (Background)

Photograph 25 and **Photograph 26** were taken by Special Agent [REDACTED] on 08/22/13 at approximately 6:20PM and depicts the source location for the collection of a background creek samples from **Sample Station 8/9**. The person appearing in these pictures is Special Agent [REDACTED] wearing an ATV safety helmet.

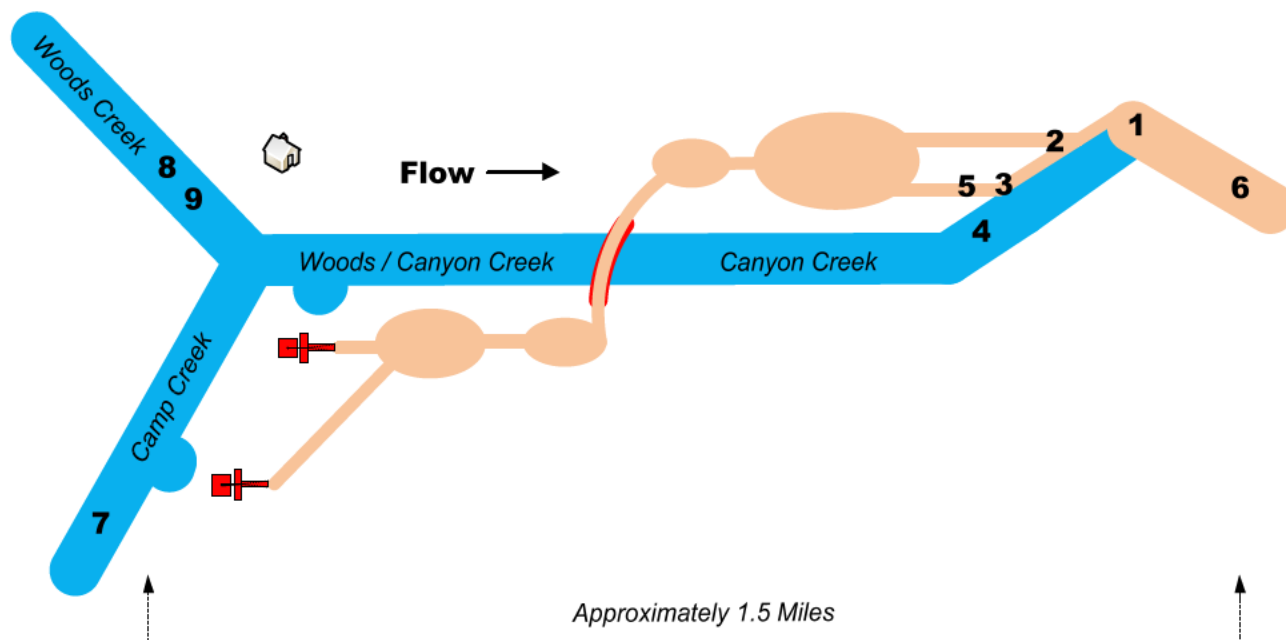
Graphic 1: Sample Stations

Graphic 1 below is provided for reference and depicts the relative location of sample stations to the point of discharge from the final settling pond. The graphic is not drawn to scale. The graphic rendering of interconnected ponds and ditches is presented to show the relative relationship among pertinent features at the site and is not reflective of the actual number of ponds or the extensive ditching network observed at the site as depicted in **Composite Photos** 1 through 4 in Section 5 of this report.

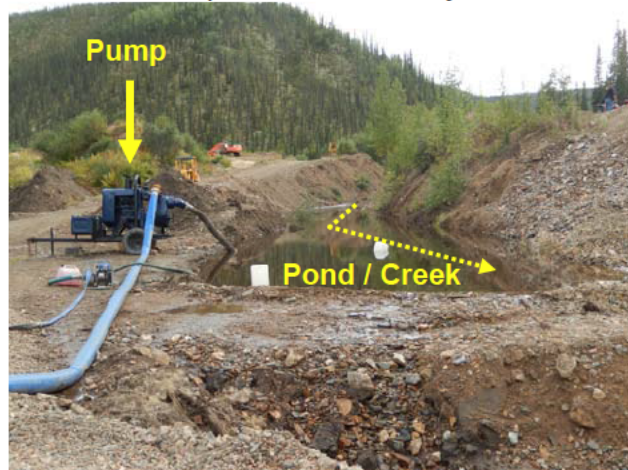
Photograph 35 also taken by Special Agent [REDACTED] on 08/22/13 at approximately 5:53 PM and depicts the configuration of the pump and hoses in relation to the freshwater pond in Woods / Canyon Creek. Reference DSCN2522.

Photo 35: Pump and hose in Canyon Creek.

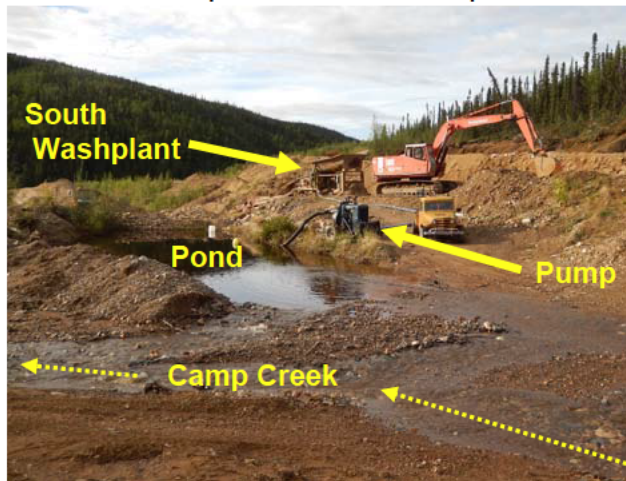
Photograph 37 was taken by EPA Special Agent [REDACTED] on 08/22/13 at approximately 6:08PM and depicts a ground level perspective of the configuration of the pump and hoses in relation to the freshwater pond in Camp Creek. Visible in the background is the South Washplant adjacent. Reference DSCN2536.

Photo 37: Pump and hoses in Camp Creek.
